# RESULTS OF THE SECOND U.S. MANNED SUBORBITAL SPACEFLIGHT JULY 21, 1961

**MANNED SPACECRAFT CENTER  
NATIONAL AERONAUTICS  
AND SPACE ADMINISTRATION**

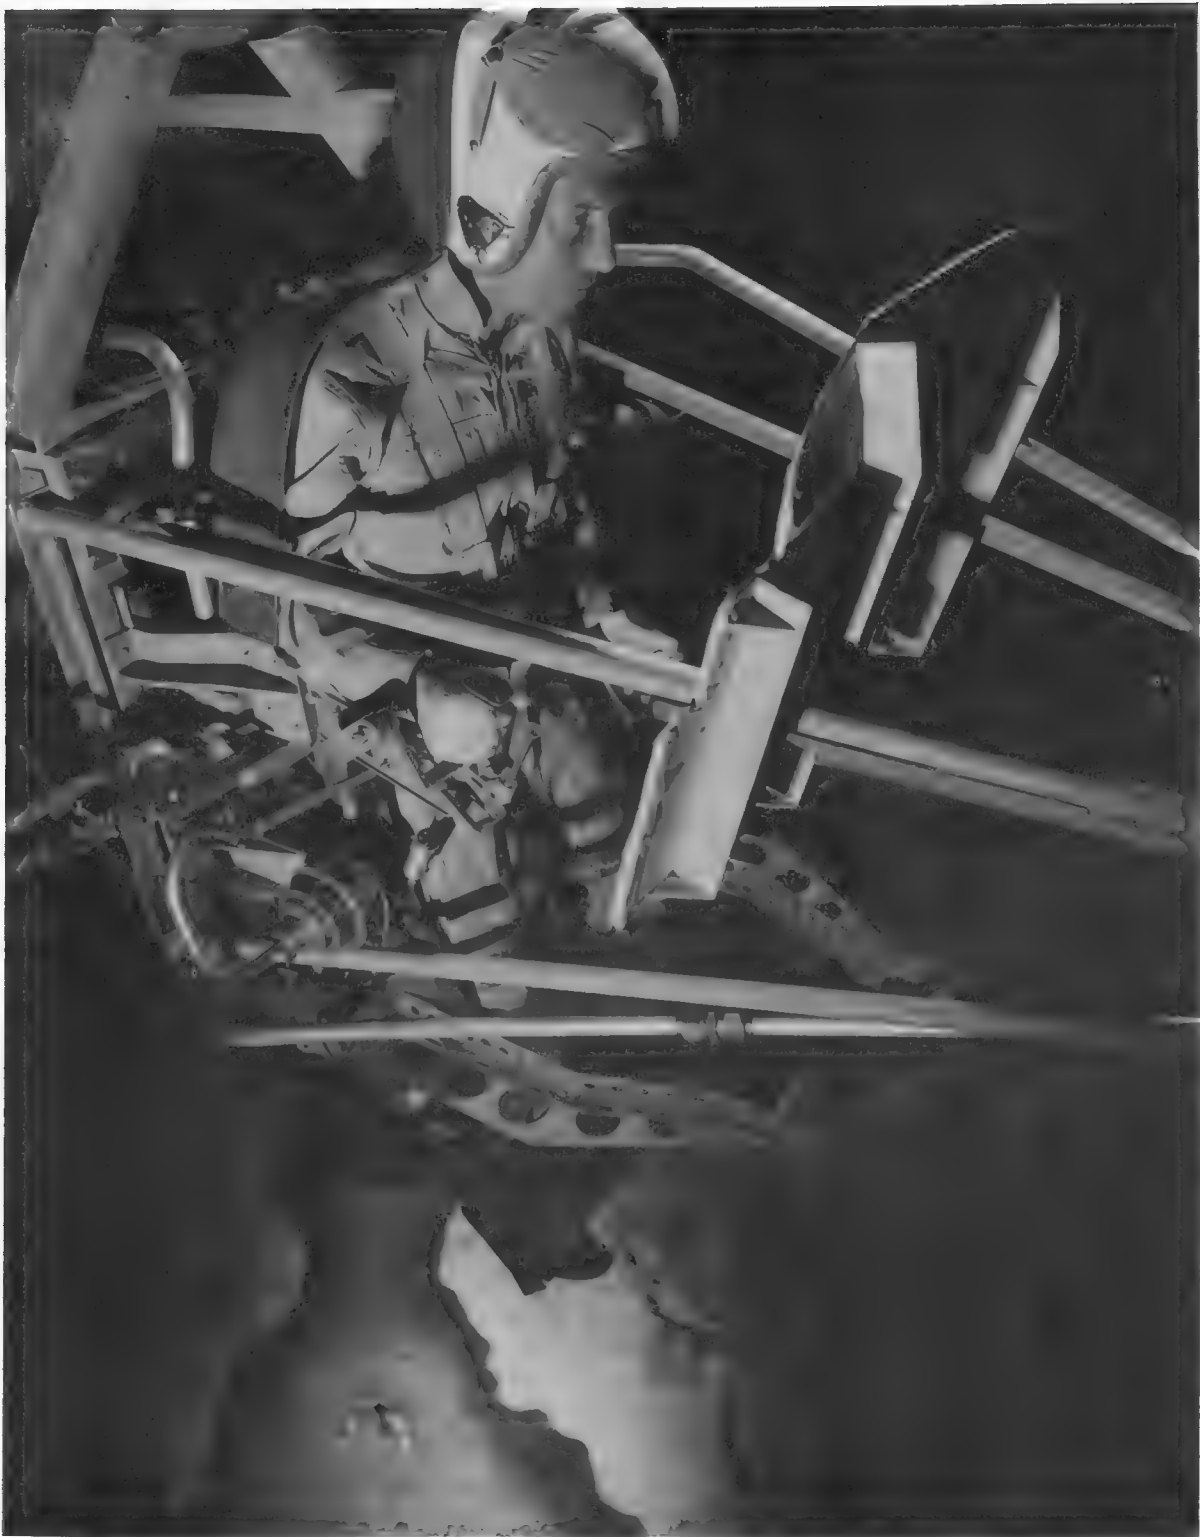
FIGURE 7-3. ALFA trainer.

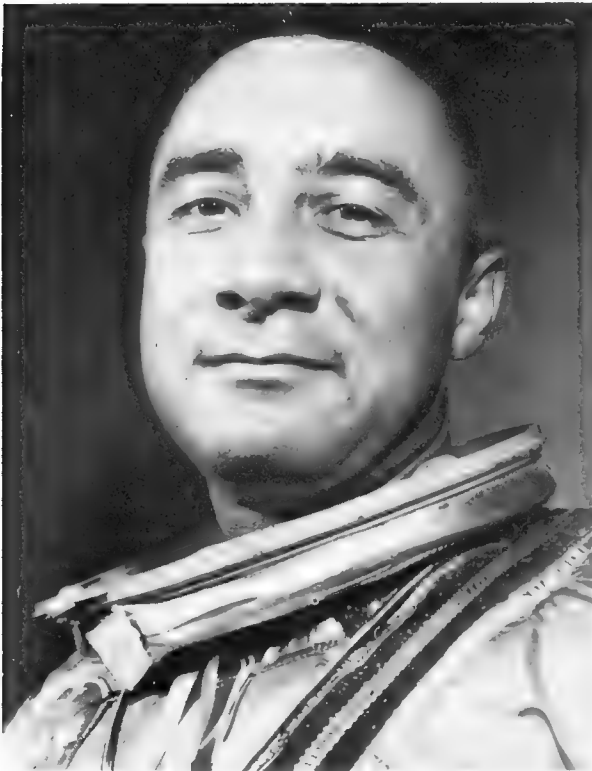
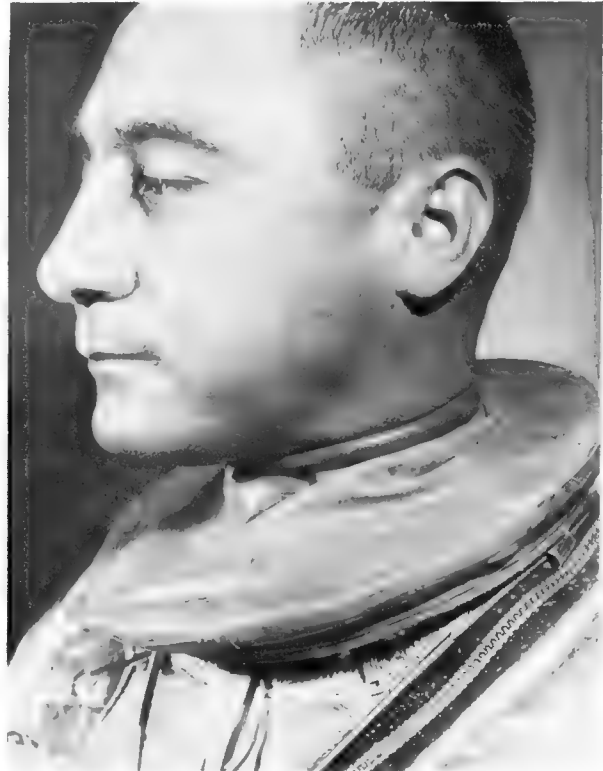
(a) Normal stored position.

(b) Unrolled position.

FIGURE 7-6. Neck dam.

I felt that I was in good condition at this point and started to prepare myself for egress. I had previously opened the face plate and had disconnected the visor seal hose while descending on the main parachute. The next moves in order were to disconnect the oxygen outlet hose at the helmet, unfasten the helmet from the suit, release the chest
